**JAMES CITY SERVICE AUTHORITY**  
Utility Operations Division

The James City Service Authority (JCSA), Williamsburg, Virginia, voluntarily joined the Hampton Roads area Consent Order to show solidarity in a continuing effort to emphasize our commitment to our customers and our environment. One primary objective of the Consent Order is the reduction of Inflow and Infiltration (I/I). Therefore, as the JCSA explored options to repair pipe defects, assurance of a watertight seal was a major consideration.

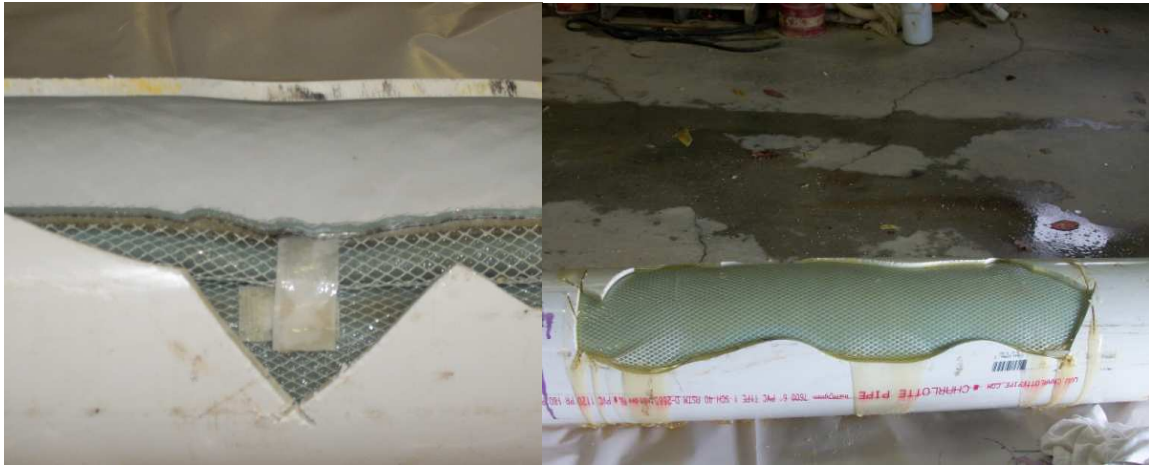
We then installed a 6-inch by 4-ft Winter Gold Liner and let it cure.

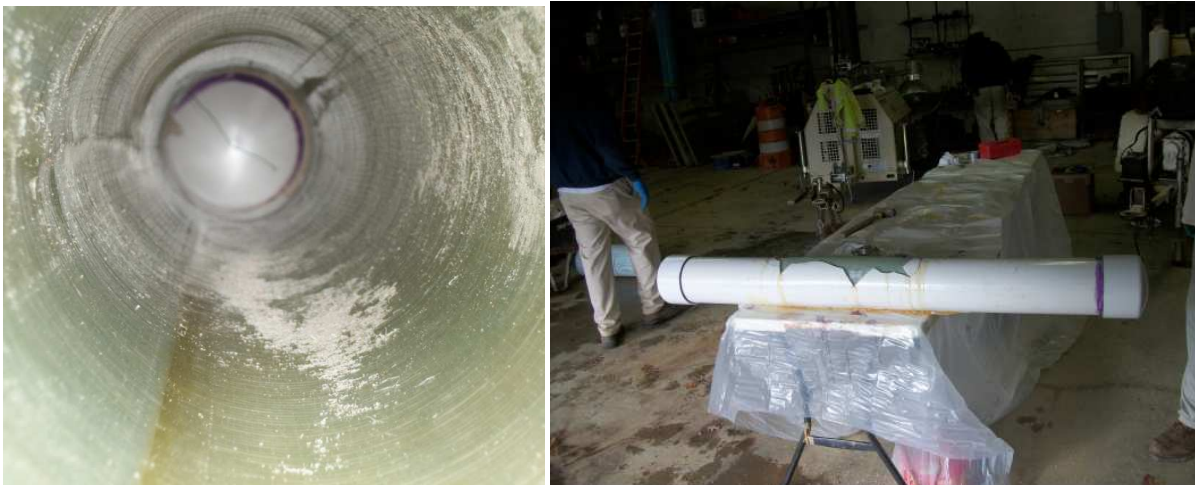
After ensuring the interior of the repaired section was perfectly dry, we glued caps on each end.

Then we fabricated a makeshift water column tank out of 12-inch diameter 20-foot long C900 pipe. One end of the C900 pipe received an MJ cap and the other left open. The C900 was set in the corner of the garage bay and secured vertically. The repaired and capped test section was placed into the pipe and mechanically held on the bottom of the C900 pipe. It was then filled with water to simulate our ground water conditions. True, the mean pressure was only about 7-psi on the repair, but rarely would we see much more in the field. That was November 22, 2010.

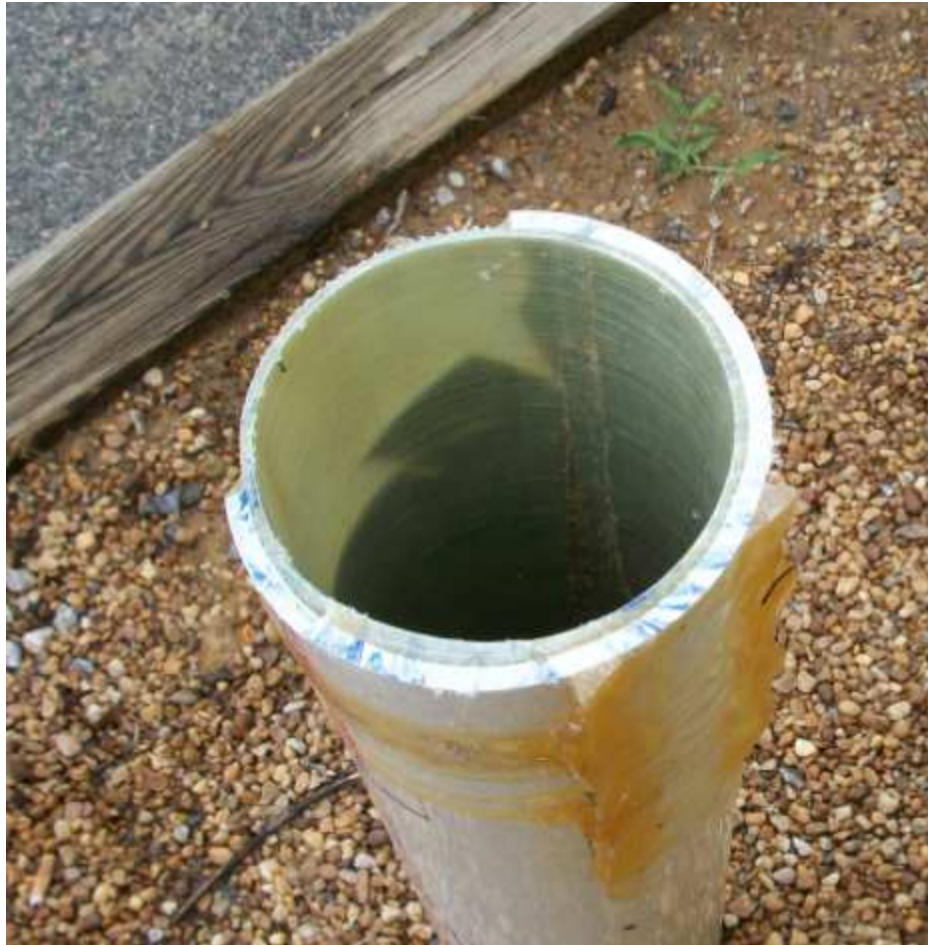
On January 3, 2011, with the Chief Engineer present, we drained the water from the C900 and removed the repaired test section. We cut it open and found it to be perfectly dry.

We examined the repaired section of pipe to see if the Gold liner had, in fact, adhered to the host pipe securely. It had. To further evaluate the liner integrity and ability to adhere we performed make-shift destructive testing.

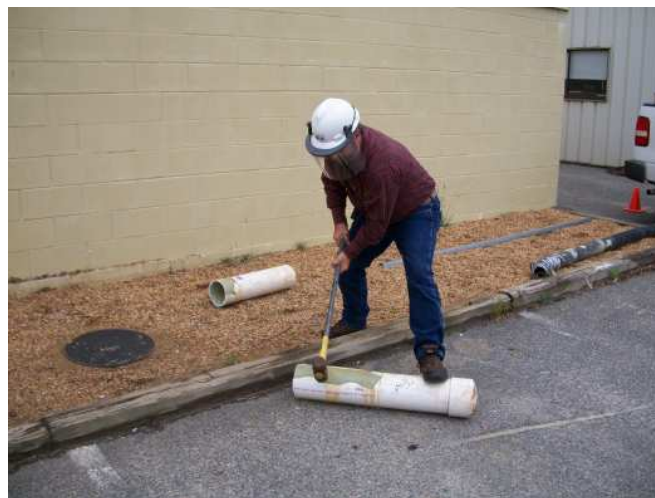
A sensational validation of cohesion was essential. Acquiring a face shield and sledge hammer, I told everyone to stand back. Using the asphalt parking lot as my anvil I struck the host pipe, the Gold liner, and a combination of the two mediums repeatedly!

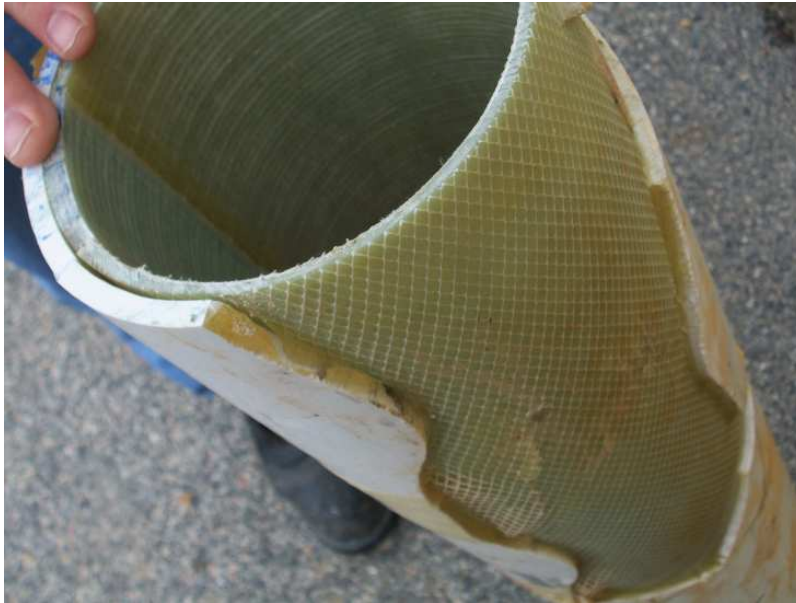
After extensive abuse with the sledge hammer, the repair never fractured through and there was only localized laminate separation while the remaining Gold liner continued to adhere to the host pipe.

The sectional liner withstood far more abuse than it would ever encounter from natural field conditions. Unlike the other point repair we were using, as a temporary stop gap repair, I now have every confidence that a repair made with the Gold Liner MIPPR restores the structural integrity of the host pipe and prevents infiltration between the host pipe and the liner.
